# **Reducing Non-Revenue Water for Multi-Village Water Supply Schemes:**

A Case Study of Hururta-Hetosa-Dera  
Utility, Oromia Region, Ethiopia

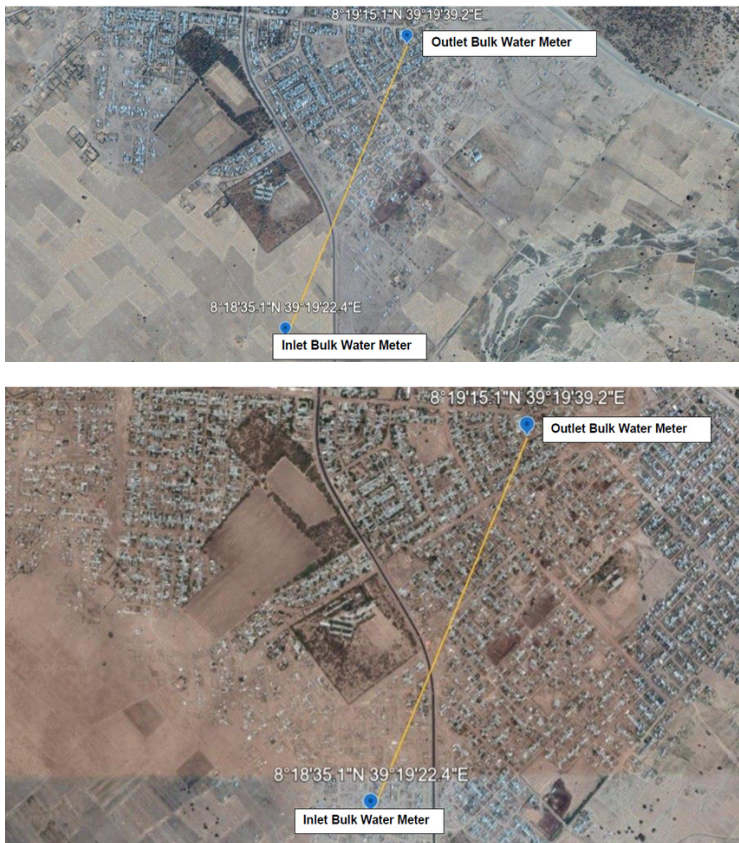
Aerial photos of the pilot area in 2012 and 2024 are shown below; these also indicate the location of inlet and outlet bulk meters installed for the pilot.

Figure 1: Aerial photos of the selected DMA showing settlement changes between 2012 and 2024

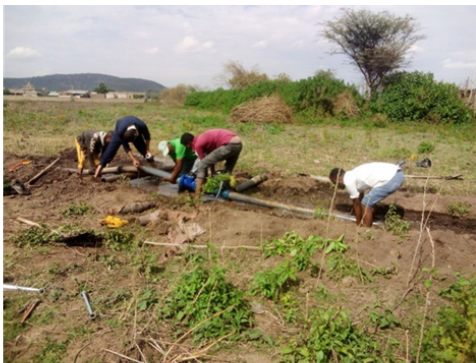
Figure 3: Bulk water meter installation at the inlet and outlet of the DMA

An early pilot intervention was to install bulk meters at the DMA's inlet and outlet points so that the volume of water entering and exiting the area daily could be monitored.

Following the installation of bulk meters, frequent blockage of the inlet meter occurred due to suspended particles in the water. It was therefore necessary to clean the meters regularly.

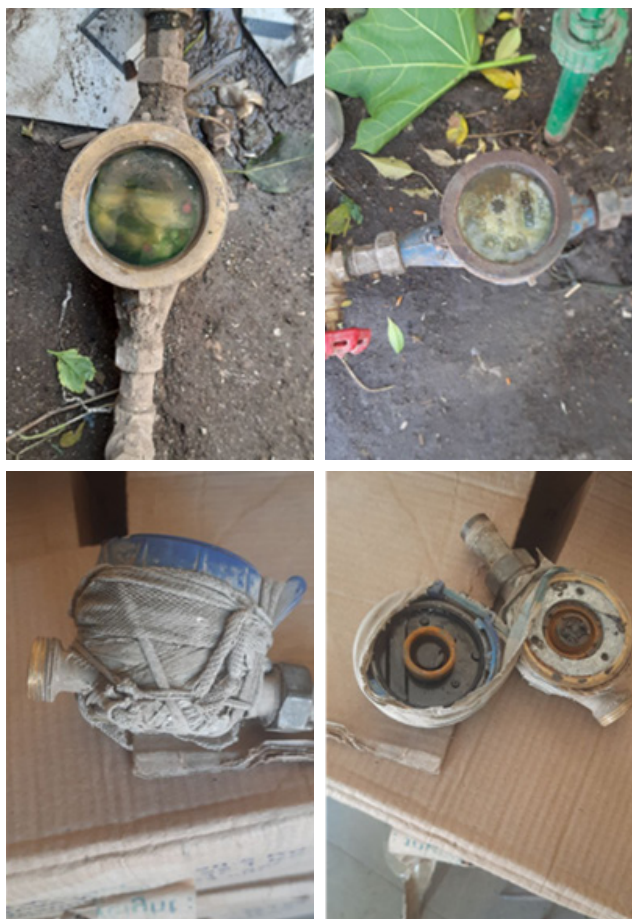
Figure 6: Sample defective customer water meters found in the DMA

The informal policy of replacing meters after ten years was not being implemented; in fact only a few branch managers were aware of it. The utility did at least record meter installation dates and based on these, 33 water meters were replaced by November 2024. TAP provided the utility with 150 new domestic meters. The remaining meters are planned for future use to replace non-functioning meters as part of the ongoing NRW reduction measures. Normally these were sold to users, but TAP encouraged the utility to provide them free or at a subsidised rate for low-income households that were unable to pay.

The replacement of 33 defective meters in December resulted in an immediate increase in recorded consumption by 38 m<sup>3</sup> in just three weeks, validating the strategy's effectiveness in reducing unrecorded water usage. TAP's support to the provision of 150 additional customer meters also enabled scalability for further reduction. Additionally, the technical team successfully reduced downtime from 12 hours at baseline to six hours. Maintenance activities are now carried out with improved efficiency, ensuring water supply is temporarily shut off during repairs to minimise losses.
